SNAP-8 MATERIALS REPORT FOR JANUARY - JUNE 1966

NATIONAL AERONAUTICS AND SPACE ADMINISTRATION
LEWIS RESEARCH CENTER

CONTRACT NAS 5-417

VON KARMAN CENTER
AEROJET-GENERAL CORPORATION
AZUSA, CALIFORNIA

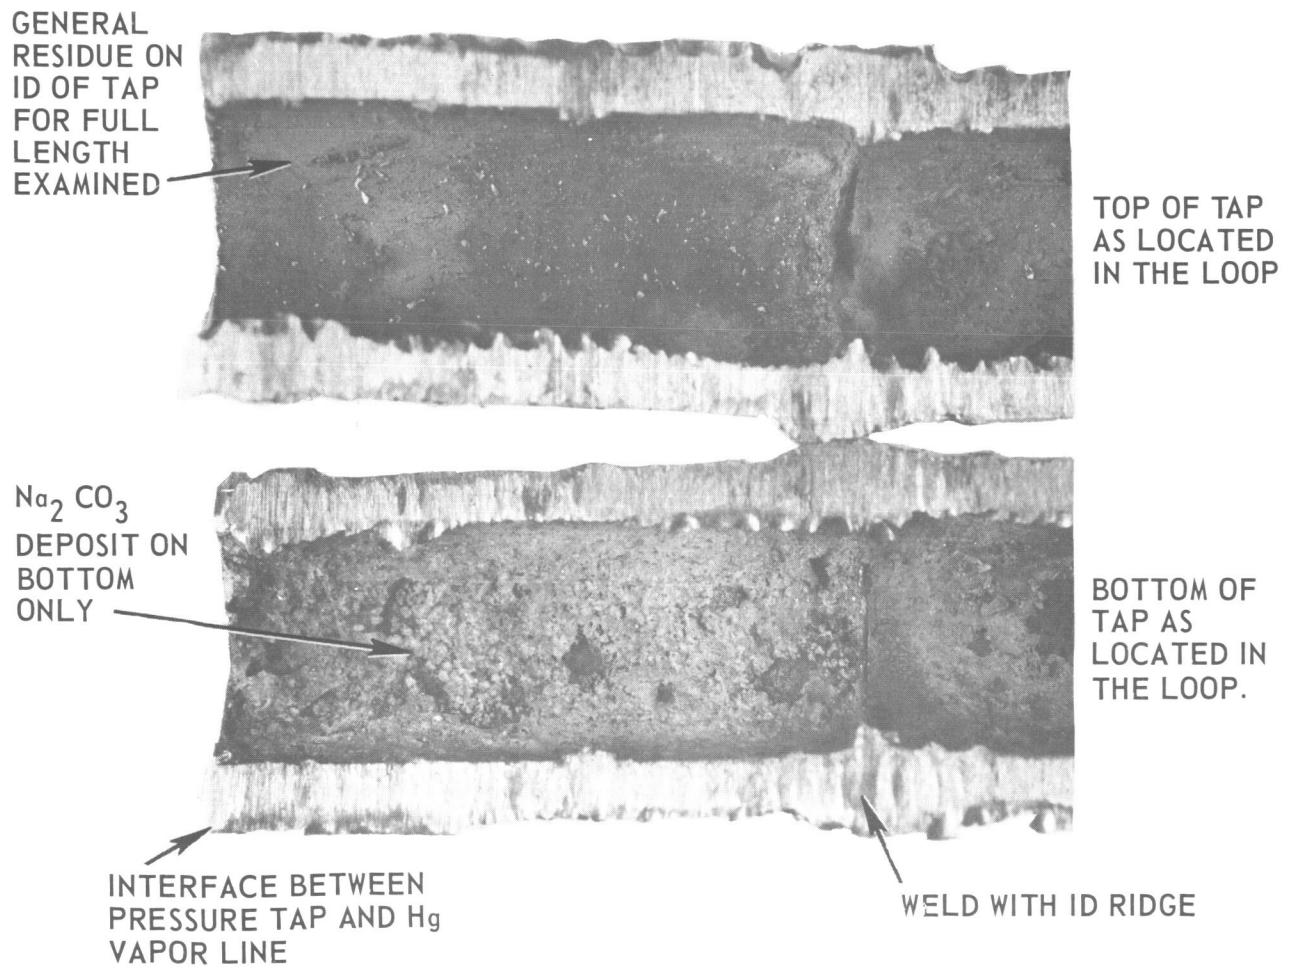
B. LONGITUDINAL TAP SECTION. APPROXIMATELY 5X.

Corrosion occurred in several 316 SS pressure taps that had operated in the Hg-vapor section of the Hg loop. The corrosion rate is estimated at 10.6 to 14.2 mils per 1000 hours. Extrapolated anticipated total life is 2500 to 3350 hours. The material was exposed to continuous Hg vapor refluxing and appeared to be insufficiently resistant to Hg corrosion. A change to 9Cr-1Mo steel was recommended.

Typical Appearance of ID of Pressure Tap from
Hg Vapor Line of PCS-1 Phase IV After Step 2 Operation

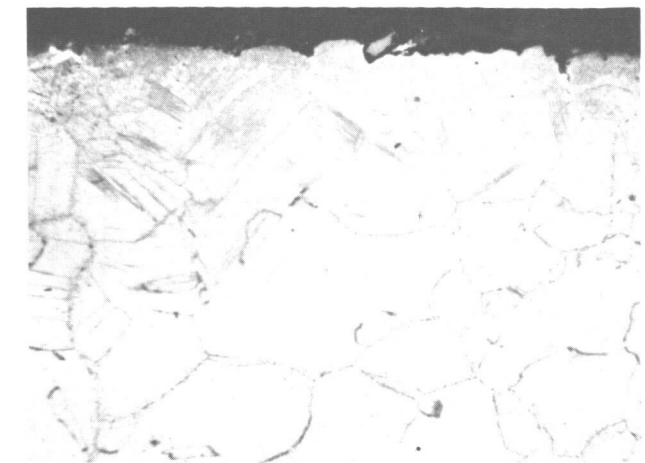
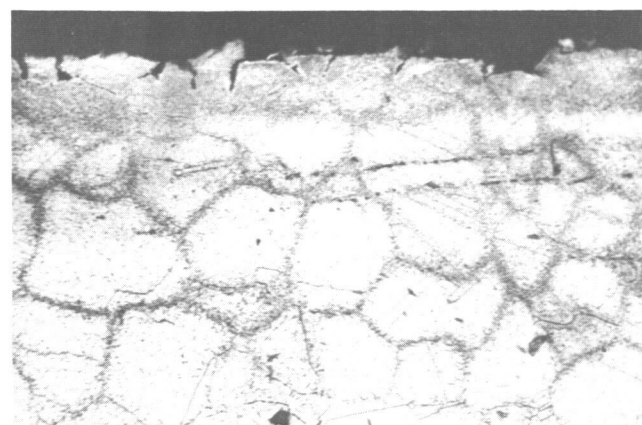
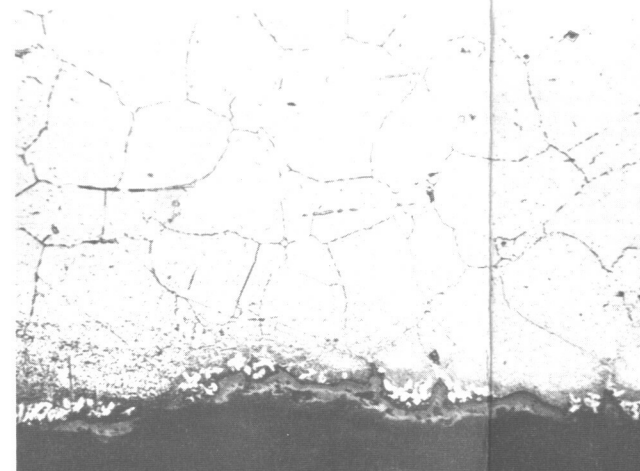
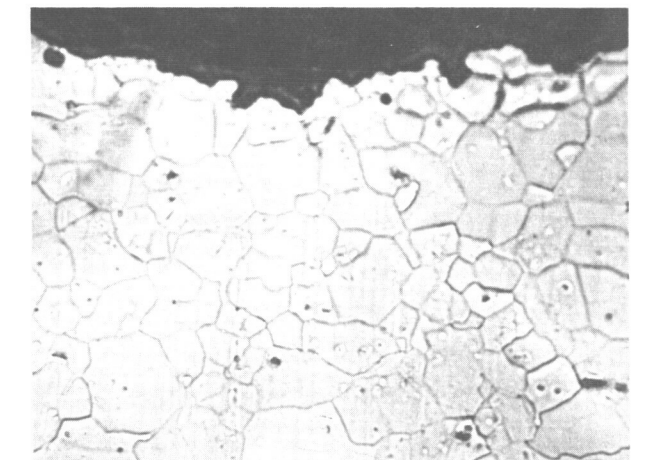
Figure 2 -1

No metallic mass-transfer deposits were found after this NaK system had operated isothermally for 2655 hours at temperatures between 1125 and 1175°F, and an oxygen content of less than 30 ppm. Carbon migration occurred from the mild steel (0.020 in. maximum decarburization depth) to the 316 SS (0.010 in. maximum carburization depth) in the system. The amount of transfer was not sufficient to deleteriously affect loop operation should it be used for additional NaK PMA tests.

L-9474 INSIDE SURFACE CARBURIZATION

L-9471 INSIDE SURFACE CARBURIZATION 500X

L-9473 OUTSIDE SURFACE OXIDATION

L-9476 INSIDE SURFACE DECARBURIZATION 500X

Microstructure of Specimens Removed from LNL-3 After 3130 hours of Isothermal System Operation at Between 1125 and 1175°F

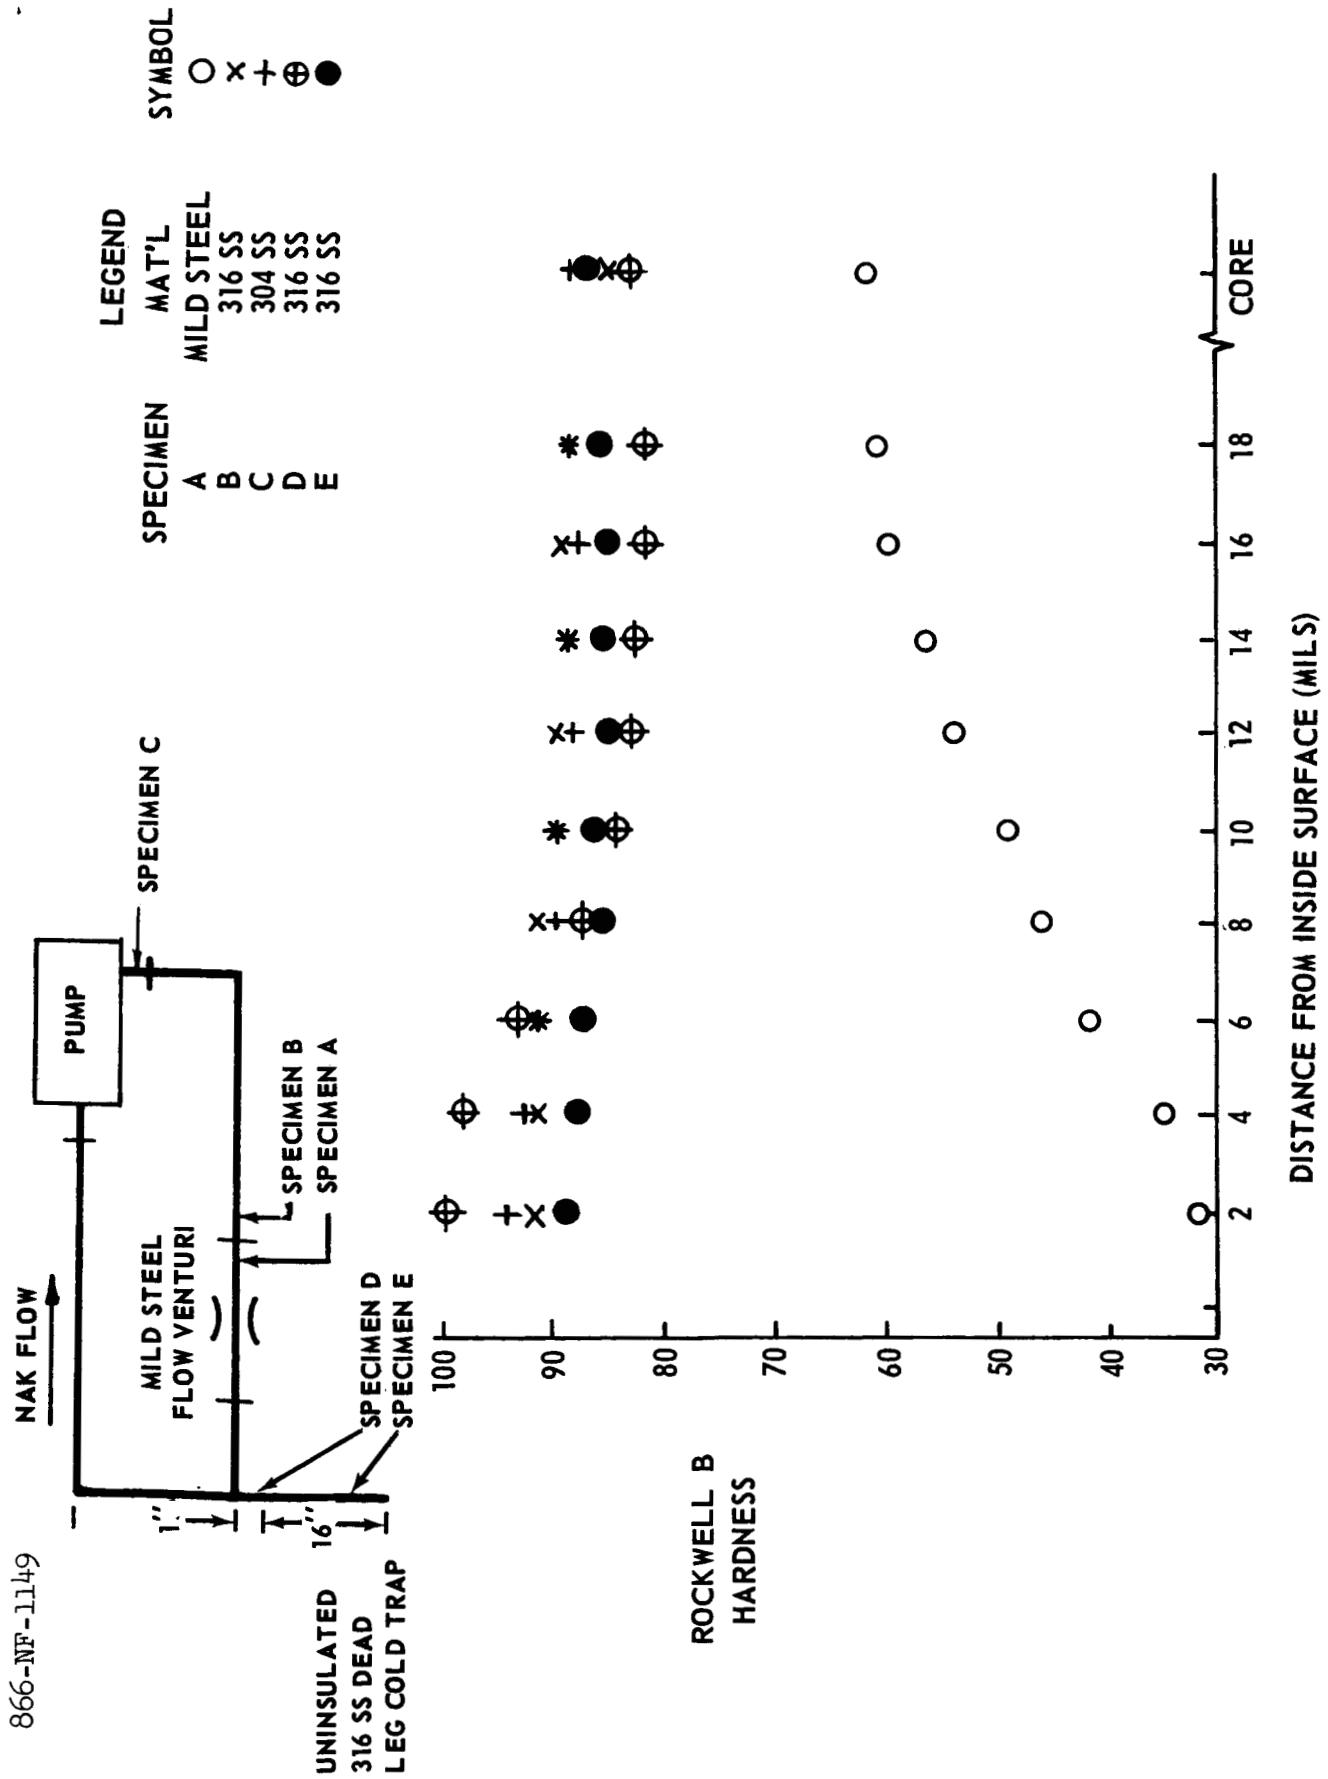
Figure 3

Rockwell Hardness Traverse from Inside Pipe Surface of INL-3 Pipe Specimens Removed After 3130 hours of Isothermal System Operation at Between 1125 and 1175°F (Hardness Converted From Knoop Microhardness Reading Taken with a 100-mg Load)

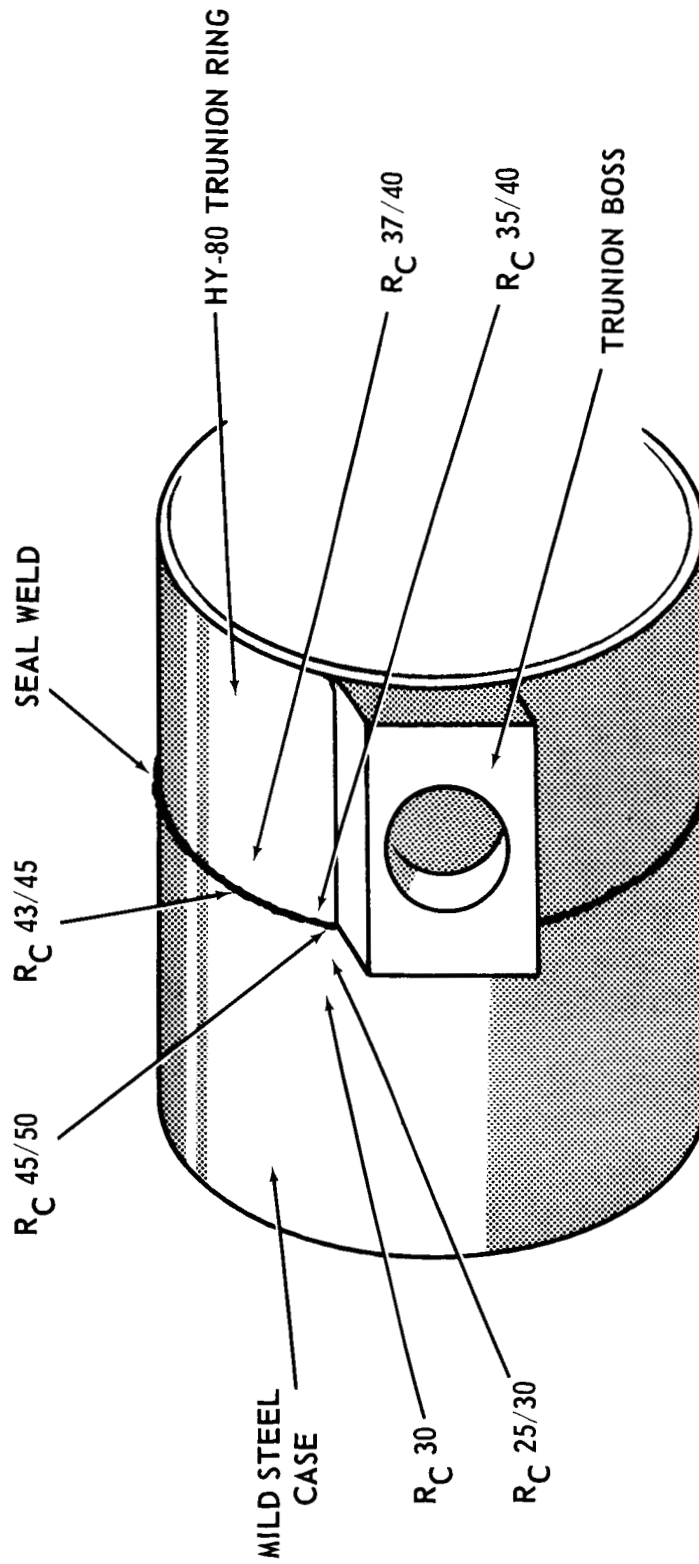
Figure 5

Qualitative Hardness Test Results on SNAP-8 Alternator (S/N 481489)
 After 140 hours of Operation in PCS-1 Phase IV Step 2
 (Higher Numerical Values Indicate Greater Hardness)

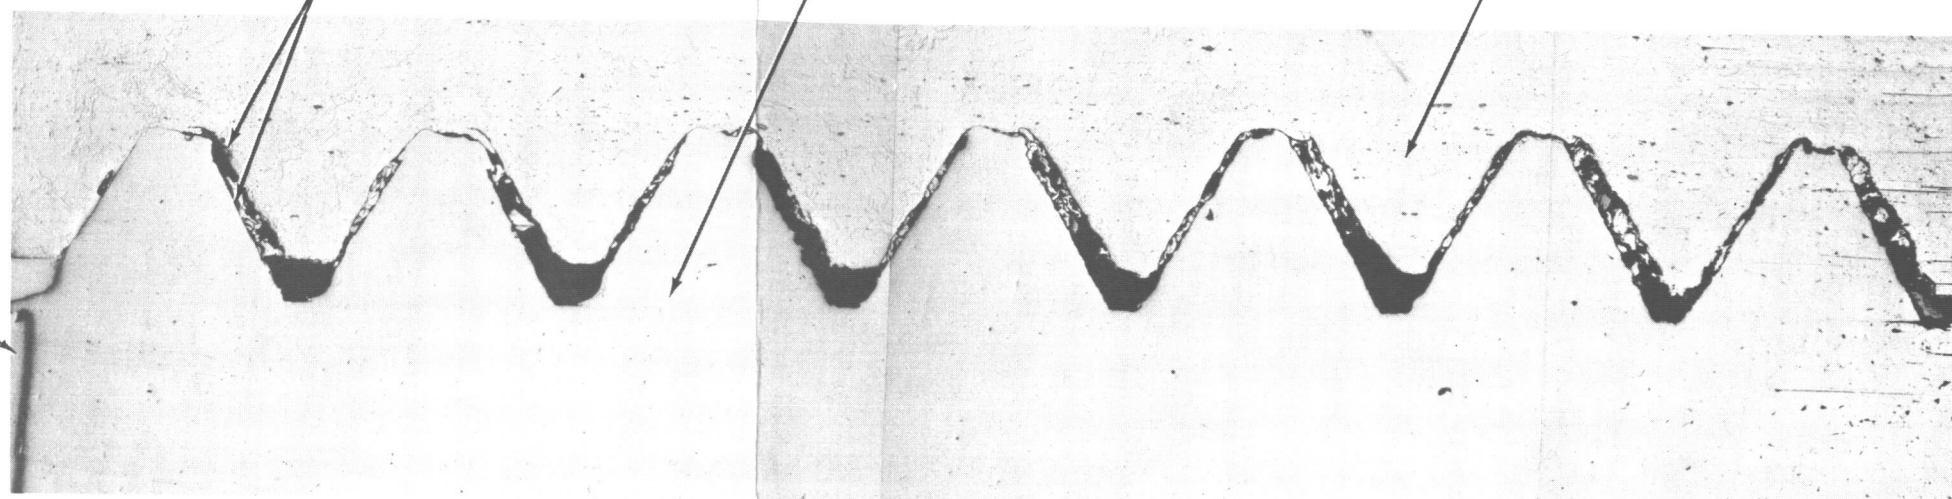
A brazed joint developed for connecting the turbine assembly interstage pressure taps was found to be metallurgically stable after exposure of samples at 1000°F (the maximum operating temperature) in air for approximately 2000 hours. No detrimental reaction occurred between the Easy Flo braze alloy and either the mild steel pressure tap or 9Cr-1Mo steel turbine case representing the S/N 5/2 turbine configuration. The joint is considered acceptable for turbine tests of at least 2000 hours duration.

A. AS-BRAZED JOINT SHOWING JOINT CONTOUR AND ENGAGEMENT OF DRYSEAL PIPE JOINT BETWEEN TA CASE AND FITTING

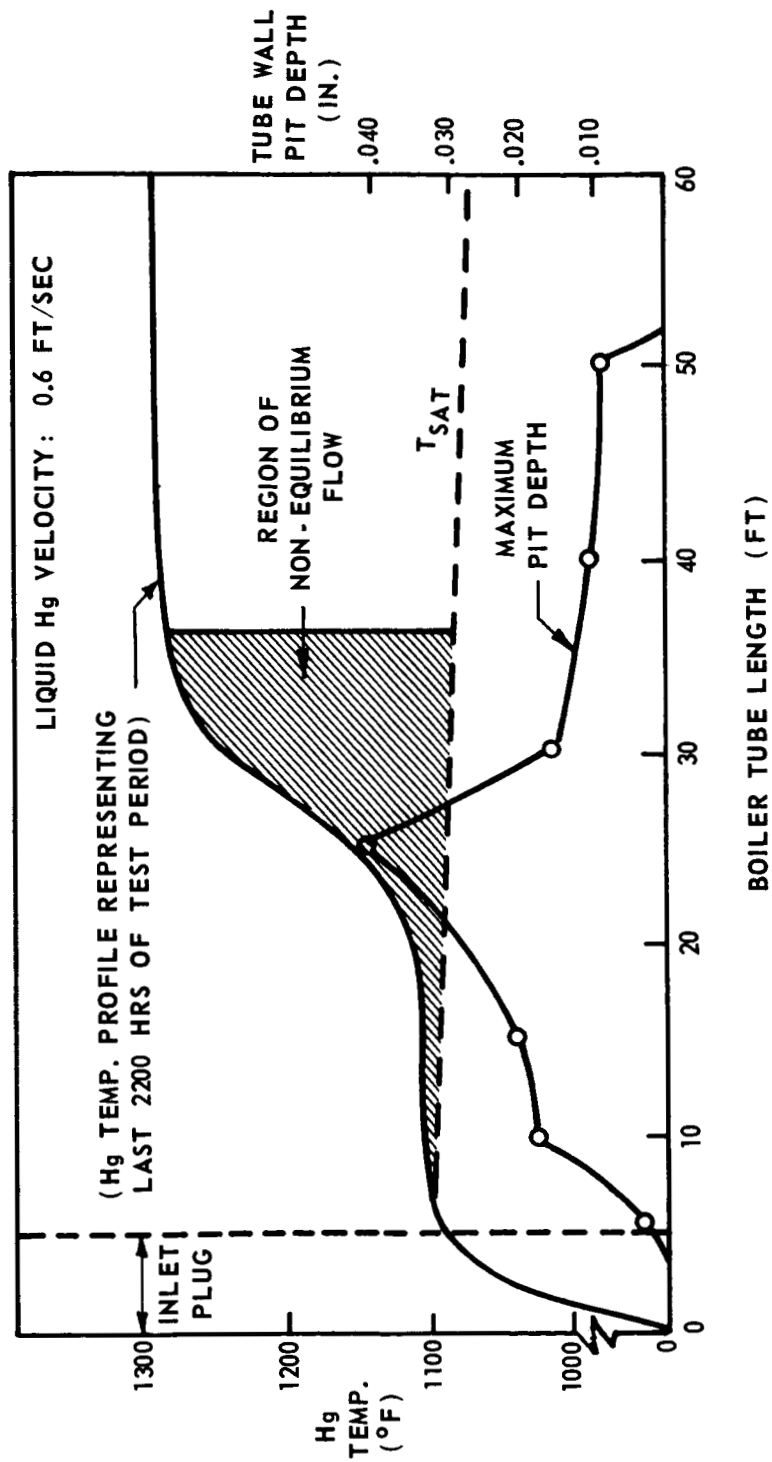
Figure 11

Corrosion Loop 3 1/19-Scale Boiler Test (Time: 4400 hours)

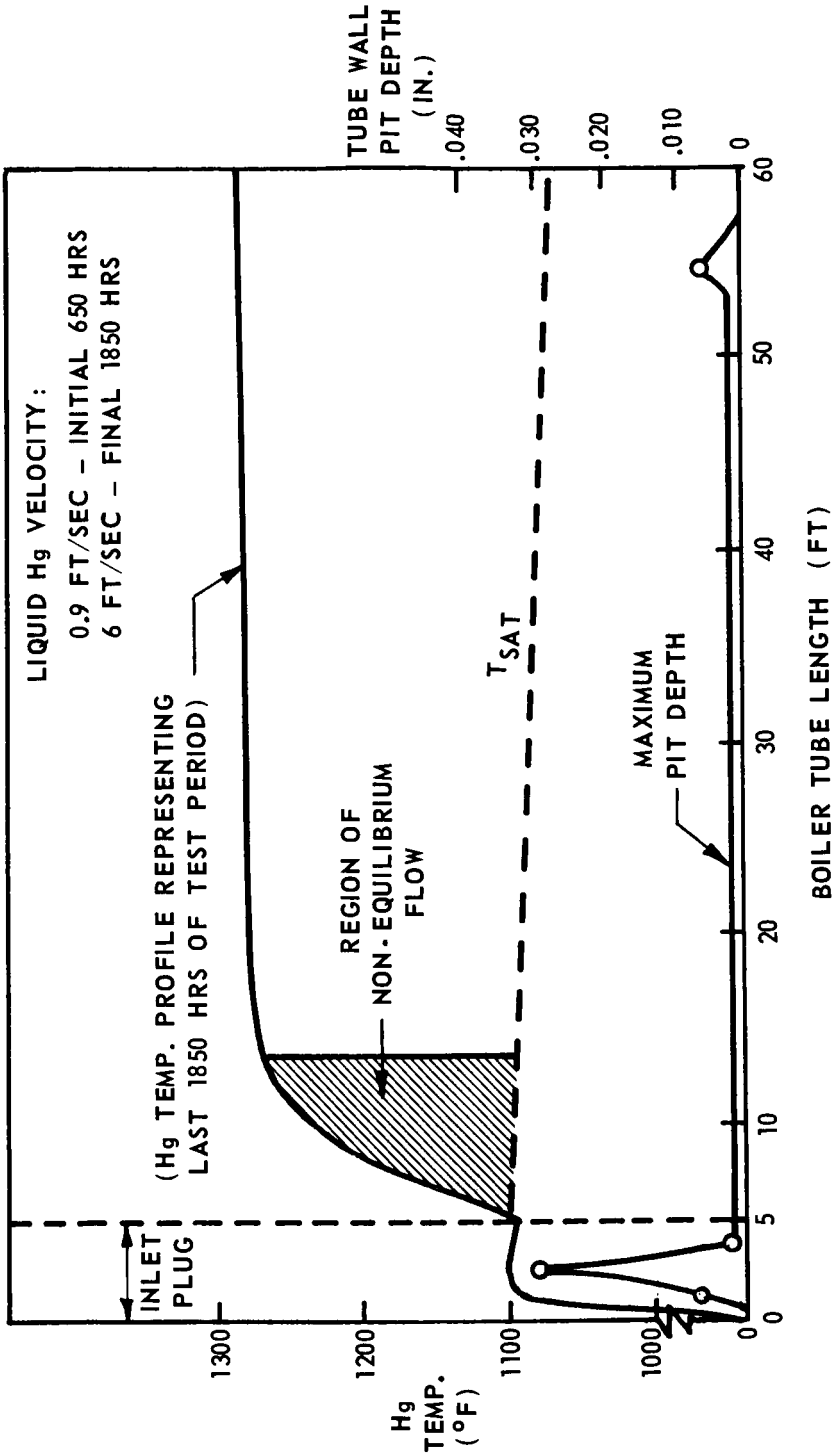
Figure 12

Corrosion Loop 4 1/19-Scale Boiler Test (Time: 2500 hours)

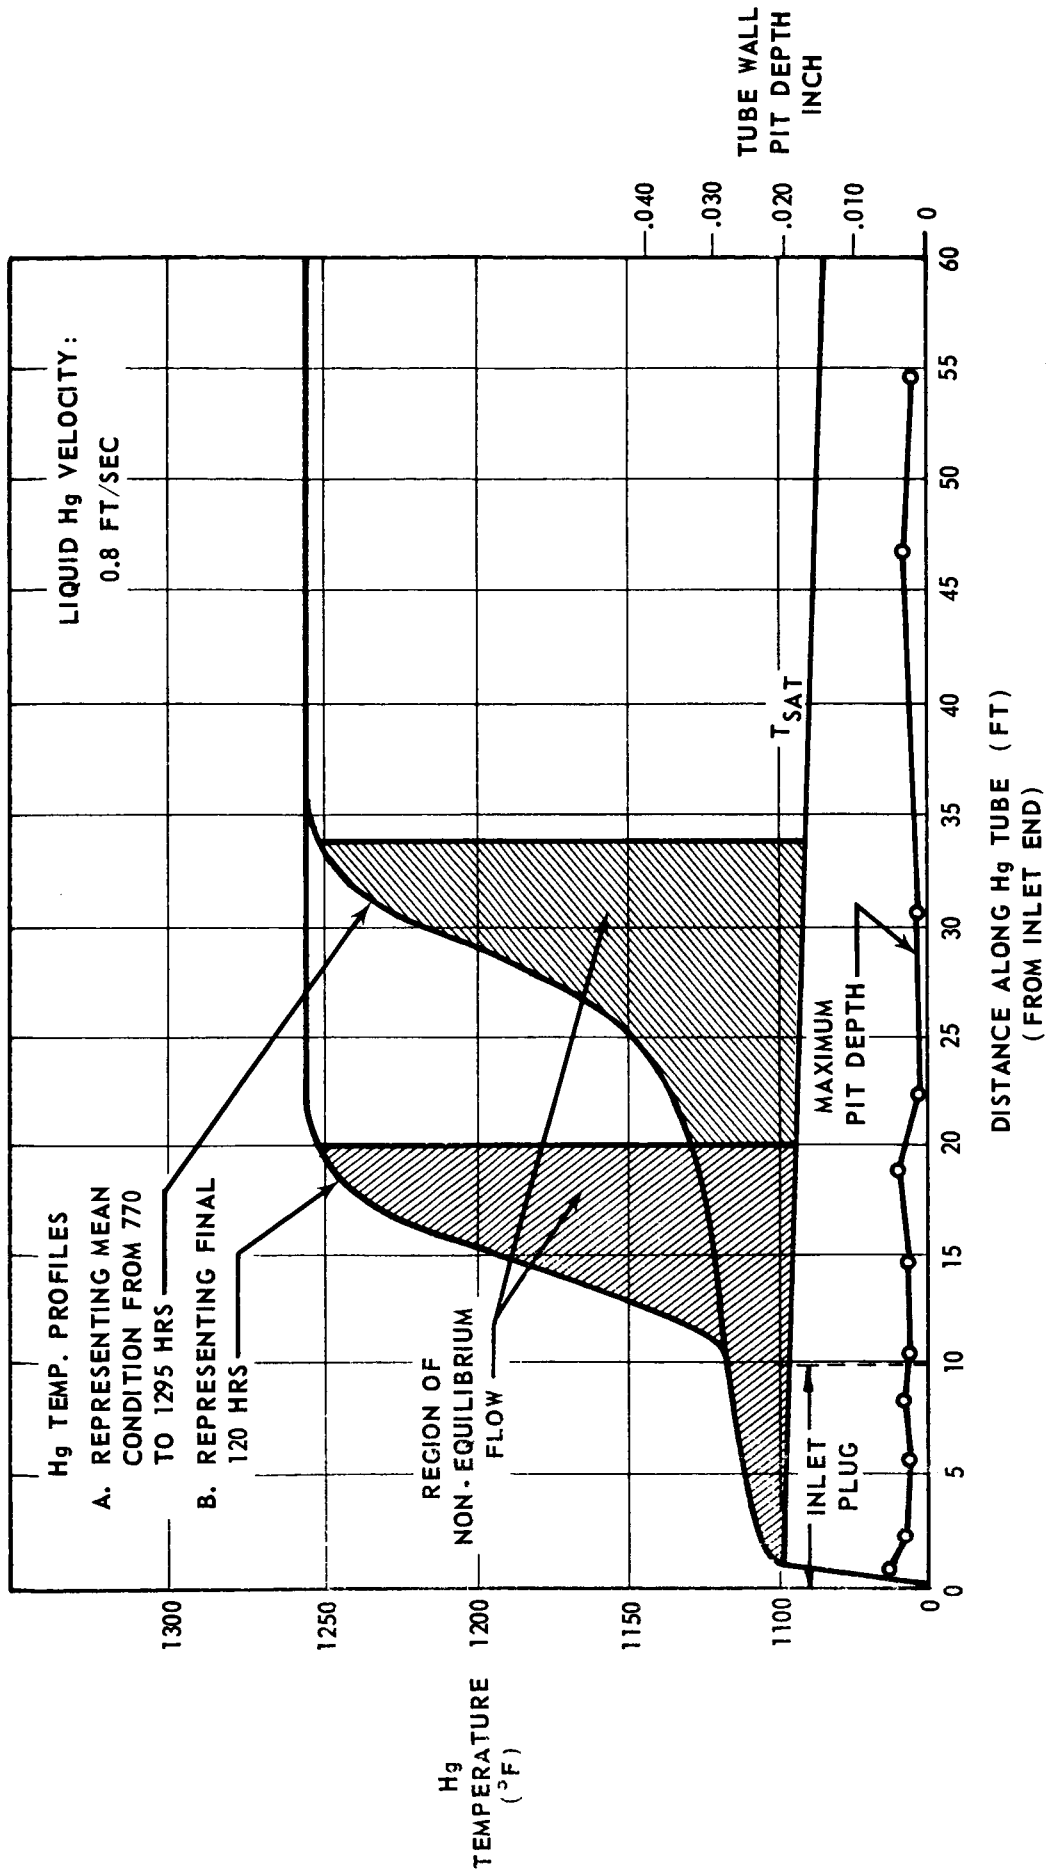
Figure 13

RPL-2 Full-Scale Tube-in-Shell Boiler Test (Time: 1425 hours)

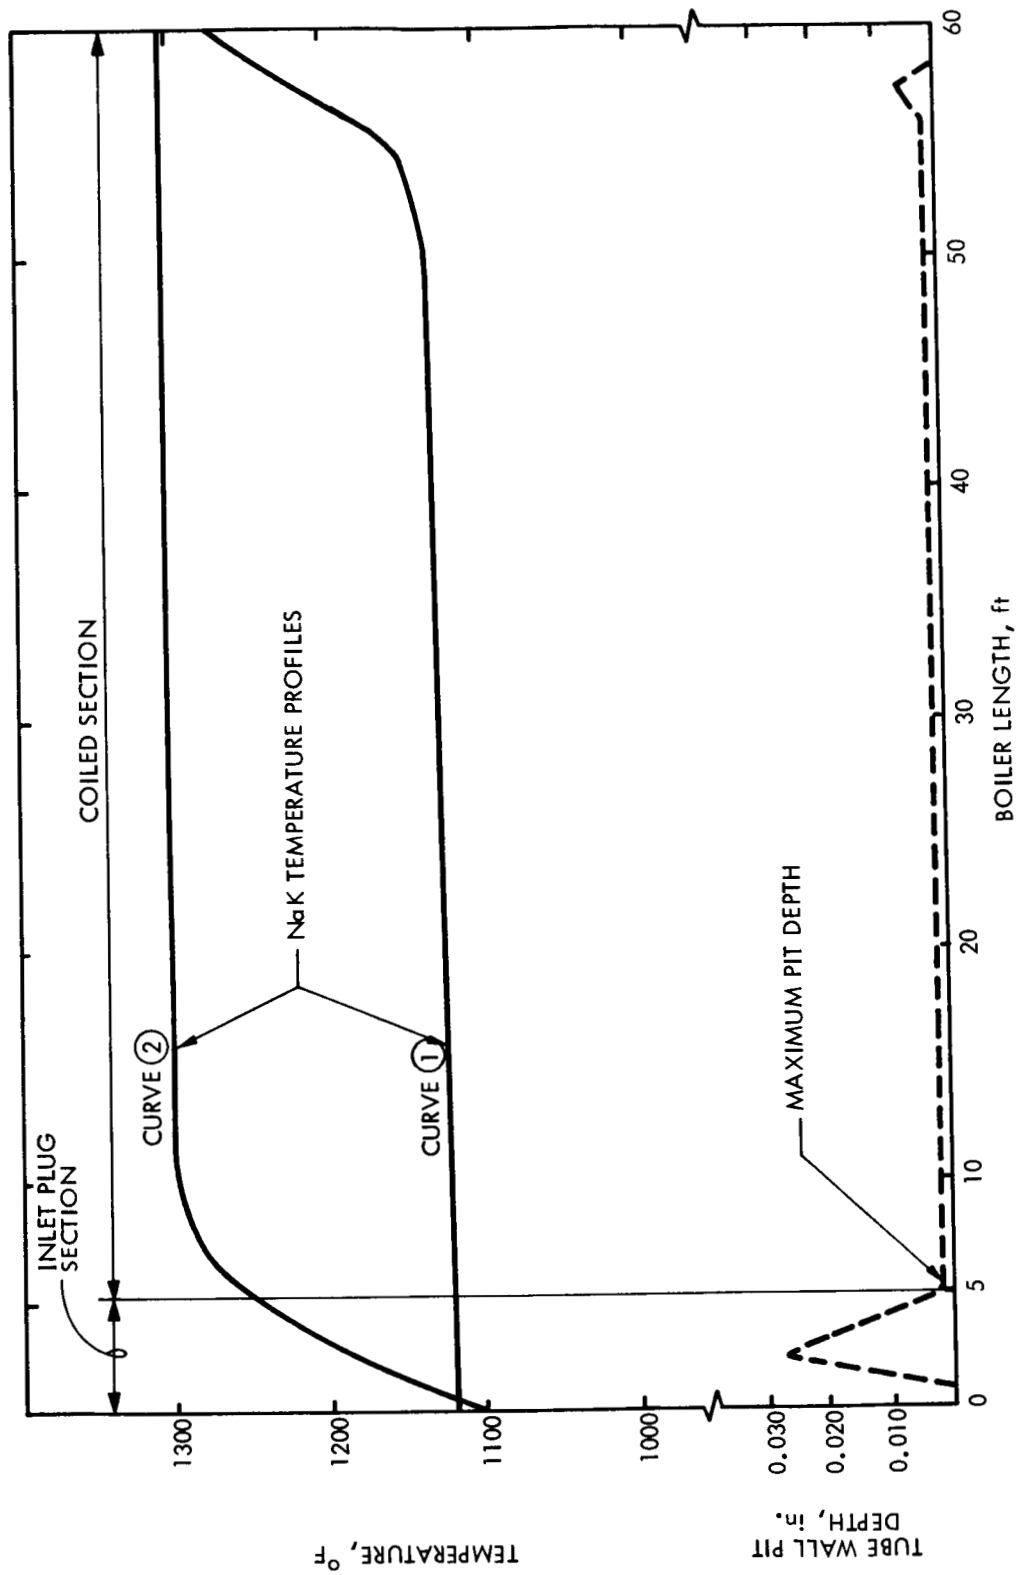
Figure 14

Typical NaK Temperature Profiles And Pit Depths CL-4 Boiler

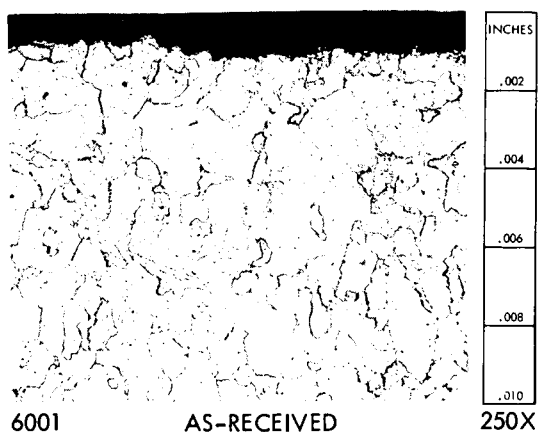
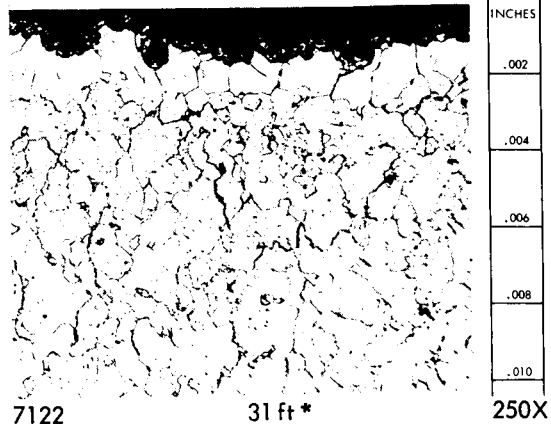
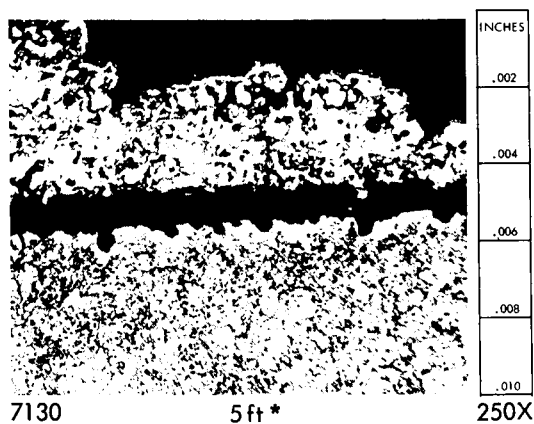
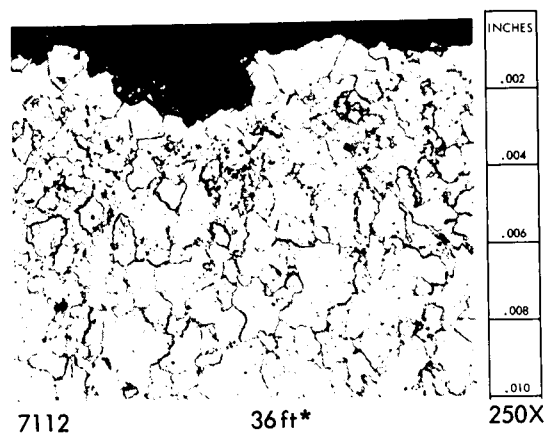
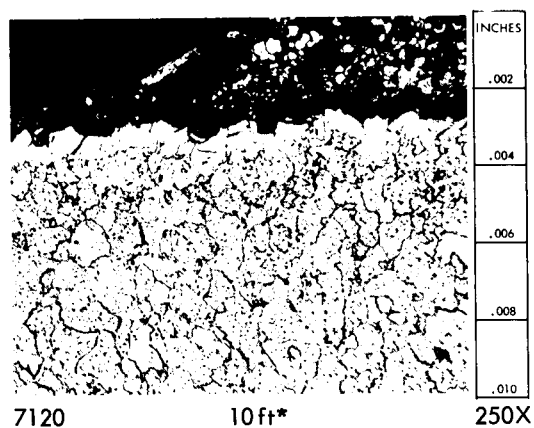
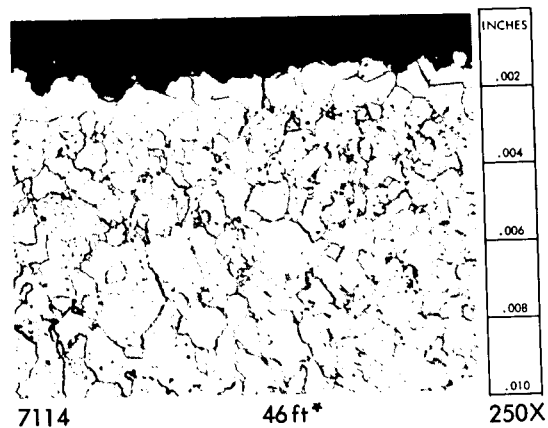
Figure 16

MICROSTRUCTURE OF THE MERCURY SIDE OF THE 9Cr-1Mo
TUBING - CL 4 BOILER COILED SECTION

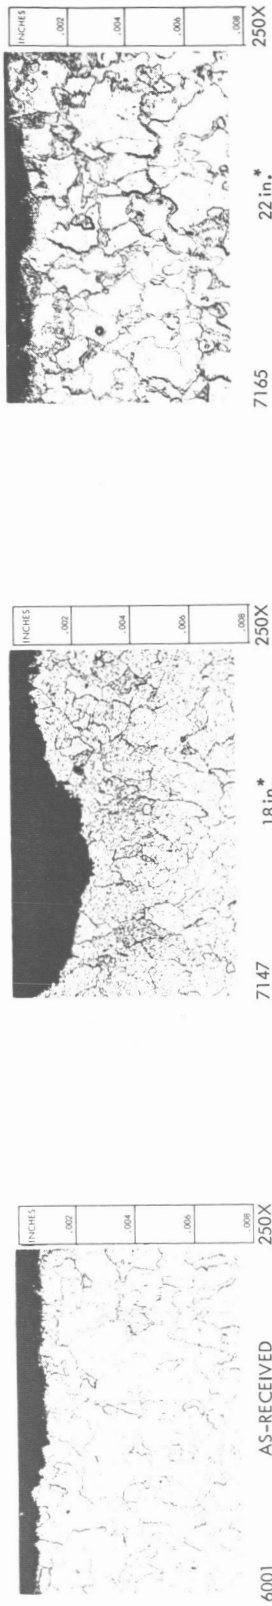
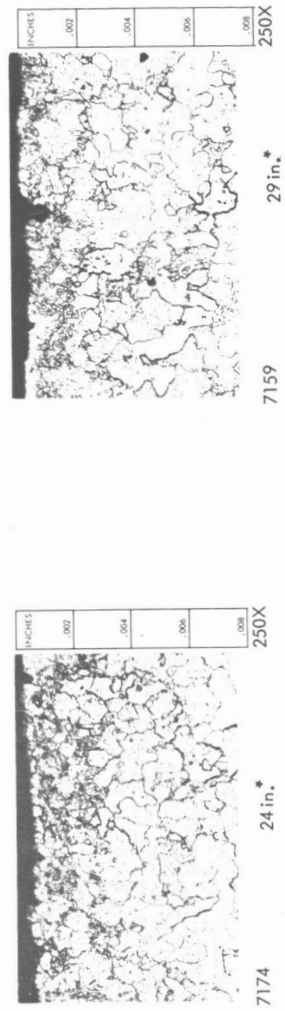
Figure 17

PHOTO MICROGRAPHS - INSIDE DIAMETER OF 9Cr-1Mo TUBING

CL 4 BOILER INLET SECTION
